1. We attach a 20-page brochure expressing "A theory as to the cause of the accident and facts not accounted for and not known to the public" concerning the Ndola accident in which Dag Hammarskjöld, Secretary General of the United Nations was killed. [REDACTED]

THE NDOLA ACCIDENT

A theory as to the cause of the accident

Facts not accounted for and not known to the public

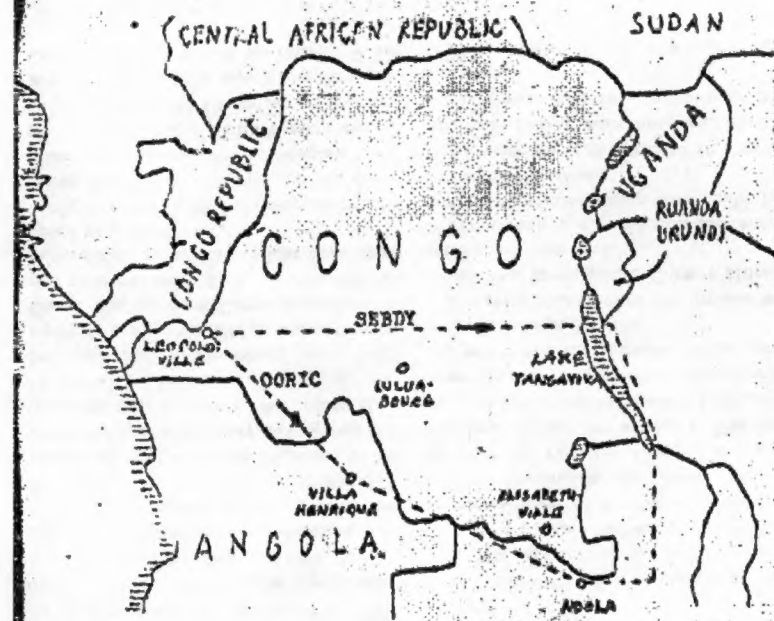
FIG. 1

OORIC	SEBDY	
Departure Léopoldville	1504	1551	GMT
Arrival Ndola	2035	2210	GMT
Flight time	5:31	6:19	Hours: Minutes
Distance flown	1120	1735	Miles

parture Léopoldville. Later it reported being over Lake Tanganyika. Neither Salisbury nor Ndola had received any advance information about this aircraft which two hours later arrived over Ndola coming from the east. SEBDY departed Léopoldville 45 minutes later than OORIC and arrived over Ndola 1 hour and 35 minutes after the landing of OORIC. Although it was 30 % faster, SEBDY used 15 % longer flight time. The route taken by SEBDY has been reconstructed and is shown -- compared to that of OORIC -- in fig. 1. It is to be noted that SEBDY flew through Nairobi Flight Information Region without reporting this to Nairobi.

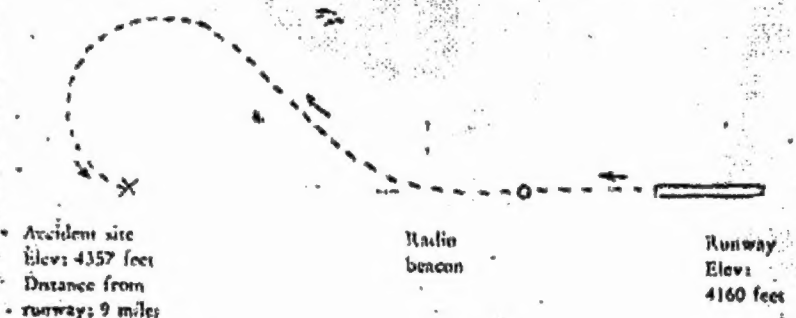
It was found that SEBDY had passed over Ndola, coming from the east, heading for the radio beacon two and a half miles west of the field. It had then made a right turn, to a north-westerly heading, and after flying in this direction for a while made a left turn. SEBDY flew in a pattern similar to the instrument let-down procedure of Ndola (see fig. 2).

After passing the airport the aircraft was headed out over an uninhabited, completely black area with no ground references.

Soon after starting the left turn the pilot gets the runway in sight and tries to estimate the distance to it. During daylight or if flying over a lighted area this may very well be done. But as the conditions were at Ndola the terrain below and between the aircraft and the runway was in complete darkness. Under such conditions it is impossible to judge the distance with any degree of accuracy. If descent is started the altitude should be decreased with decreasing distance to the runway. And under the above related circumstances it was quite impossible to judge the height.

During the turn he got the runway in sight. The conditions were ideal for an optical illusion. A contributive factor may have been that the Ndola runway is very narrow. Deceleration in forward speed and acceleration downwards due to the turn contributed to a complete sensory illusion which made the captain believe that he was too high. He ordered "Flaps 30", kept the power setting low and went into a descent of more than 1000 feet per minute. The co-pilot being overstressed failed to check the altimeter and went on with the check list. The captain, eyes on the lights, lessened the turn to line up the aircraft with the runway. Being satisfied that he was now on correct glide path he increased power. Keeping the correct approach speed he hereby raised the nose of the aircraft, and thus, still being the victim of an optical illusion, the captain thought that the aircraft was fully safe when it descended into the ground.

field in order to make a normal landing circuit. He would no doubt have been cleared accordingly and told to report on down-wind leg. He would then have made a left turn back to the field, arrested the descent at 6000 feet and let the speed drop off. When circling the field he would have lowered the altitude to circuit height — field elevation plus 1200 feet — in this case 5400 feet. He would have positioned the aircraft on down-wind leg parallel to the runway flaps set at 20 degrees maintaining a speed of 140 knots. When abeam the runway end he would have lowered the landing gear, soon afterwards starting a descending left hand turn down to the runway. This is the most simple and safe method of approach there is and every pilot is trained in it. The crew would have had plenty of time to prepare itself for the landing and the final approach would have been made close to the runway thus greatly eliminating the risk of erroneous judgment in height.

Other pilots would have asked for a clearance to make an instrument approach. When passing the radio beacon they would have turned 45 degrees right to a north-westerly heading. After 45 seconds they would have started a left hand turn back to the field. During the procedure they would have stopped the descent at 6000 feet and let the speed drop off. At 165 knots flaps would have been set to 20 degrees. After the turn back the correct moment to start final let down would have been judged by observing the runway lights. The descent would have been started by lowering the landing gear, the aircraft would have been lined up with the runway and the altimeters carefully checked during final approach. During the procedure turn the aircraft would have been as far away from the field as 8 to 9 miles.

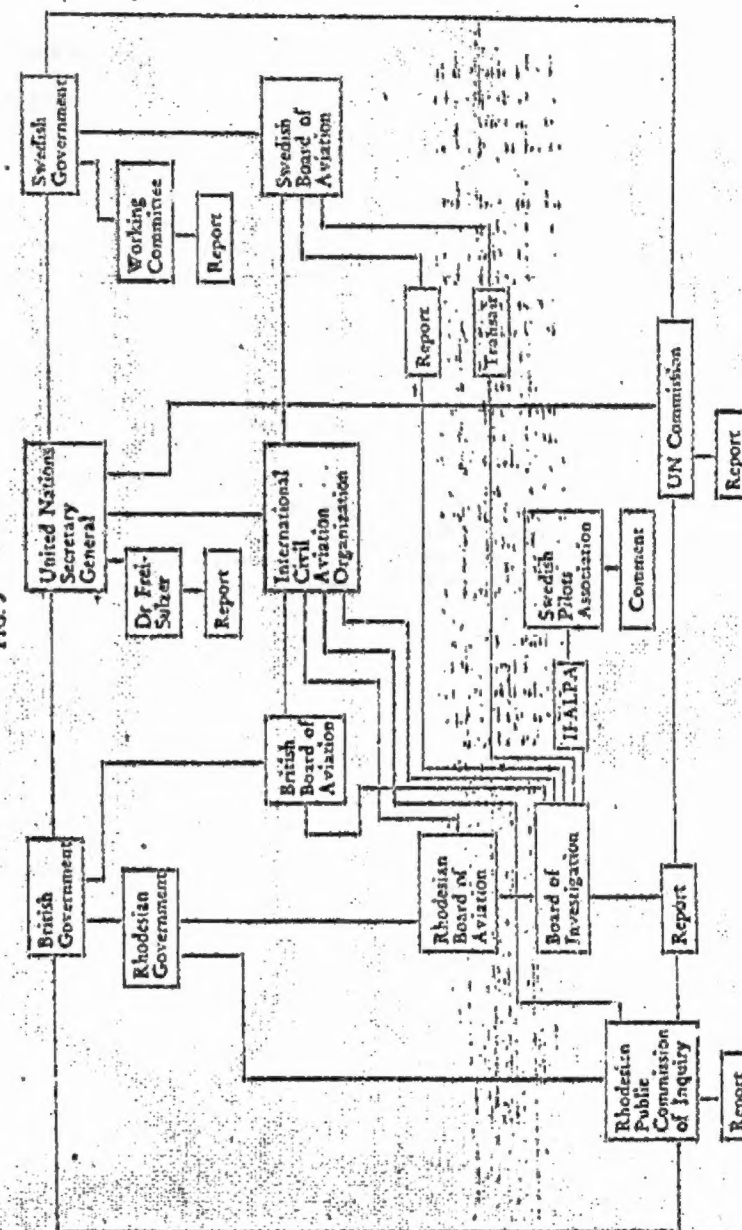
FIG. 3

The Board of Investigation worked on four theories that had been laid down beforehand, i.e. enemy action, sabotage, technical malfunction and pilot error. By discussing the first three of these theories and concentrating all work on them they were eliminated, and pilot error was indicated as being the cause of the accident.

It is the first time an accident investigation has been treated this way which becomes disastrous when the different theories appear again in a summing up. It was certainly so in this case as the possibilities for pilot error were not discussed and the operational data with a bearing on pilot error were missing.

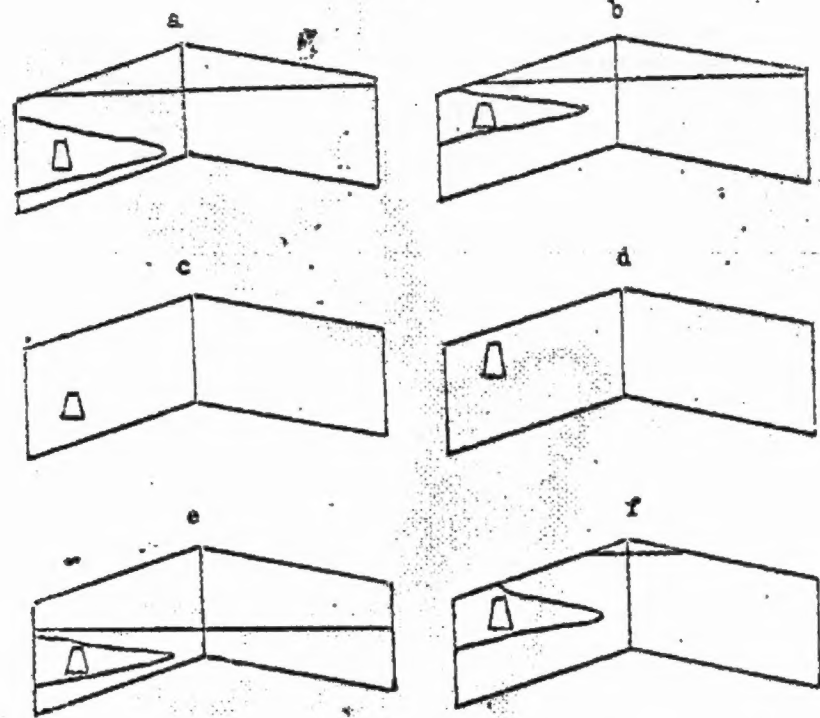
FIG. 4

A runway situated on a tongue of land is seen through the cockpit windshield of an aircraft approaching over the water under different conditions. The distance to the runway is in all instances the same — about half a mile.

In c) and d) the approach is made during night. There is no horizon and no land

contours. Only the lights forming the runway can be seen. It is then plausible to assume that the aircraft is on correct glide-path in c) and too low in d). The conclusion is arrived to by imagining the horizon and put it at the same place as in a) and b). It is kind of a second nature with pilots to imagine where the horizon is when it cannot be seen.

The assumption as to the aircraft's position in relation to the glide-path in c) and d) may be correct, but it may also be completely wrong.

As can also be seen from fig. 4 the runway contours give different perspectives depending on which height it is seen from. This is a condition that is used by many pilots. They carry in mind a picture of the contour the runway should form when seen from the ideal glide-path.

The farther away one is from the runway the more difficult it is to judge the correct glide-path. The error in height caused by misplacing the horizon increases with increasing distance from the runway. A one degree misplacement of the horizon means less than 50 feet error in height at a distance of half a mile — as in fig. 4. At 9 miles distance — as at Ndola — it means 825 feet error in height.
